# Overview of Acid Sulfate Conditions, Weathering Processes and Effects

W. Lee Daniels

## Objectives for Today

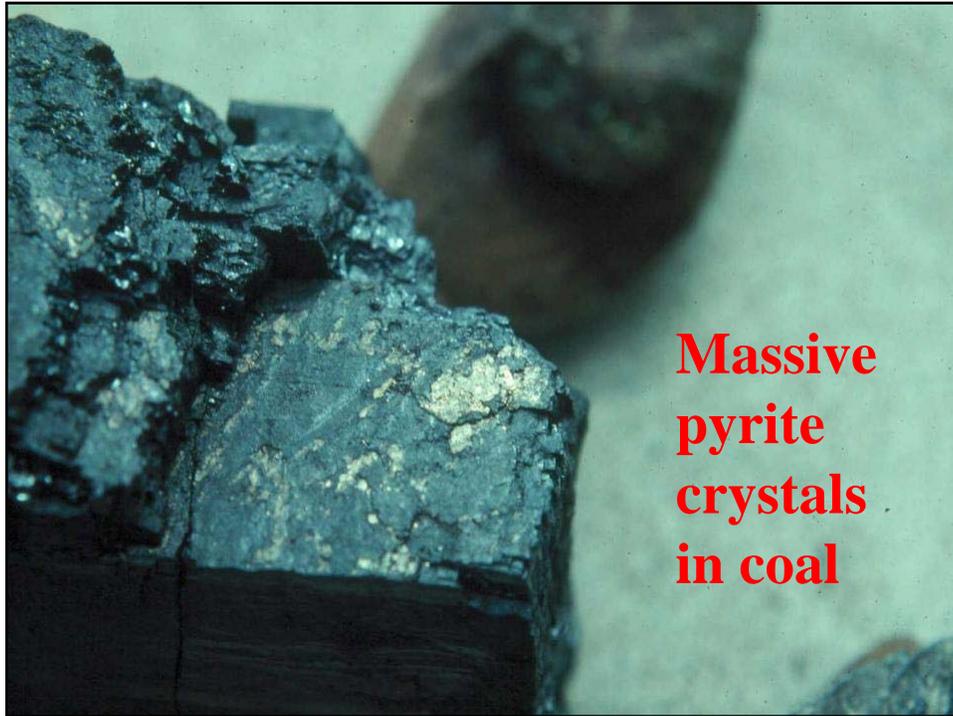
Figure 10.1 Diagram illustrating sulfidization.

Fig. from Fanning & Fanning.

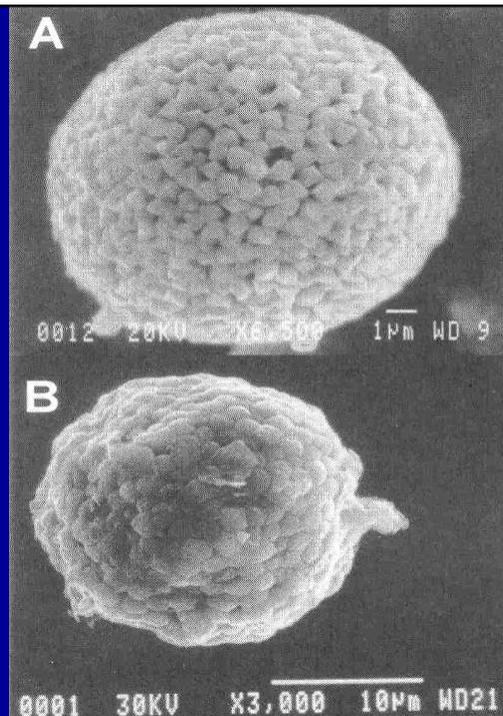
**Framboidal pyrite forms from Fanning et al. (2002). Finely divided framboidal pyrite is much more reactive than larger and more crystalline forms.**

**Also occurs in other sizes/forms in sediments and rocks.**

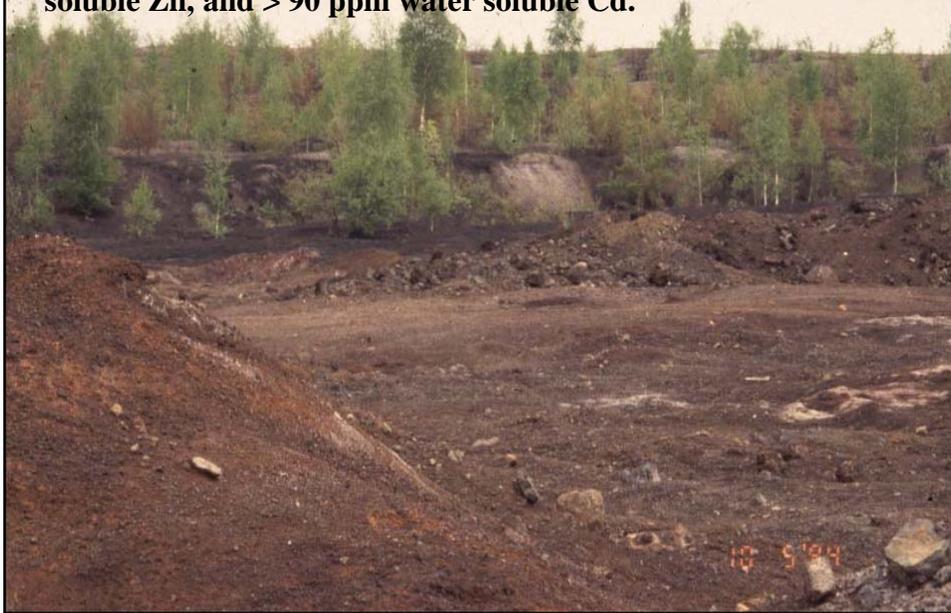
**Acidic, high S Pb/Zn smelter slag site in Katowice Poland in 1994. Materials were 3 to 10% total-Zn, > 1000 ppm water soluble Zn, and > 90 ppm water soluble Cd.**

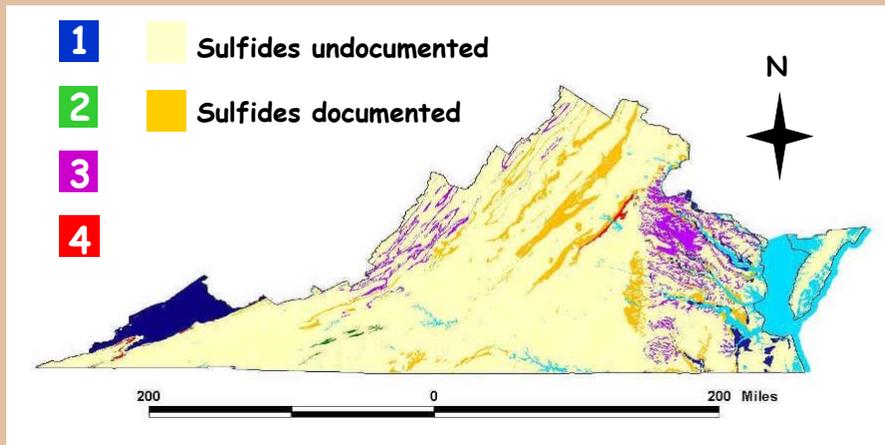
### Compiling a state-wide sulfide hazard map for Virginia: the final map. Orndorff 2001

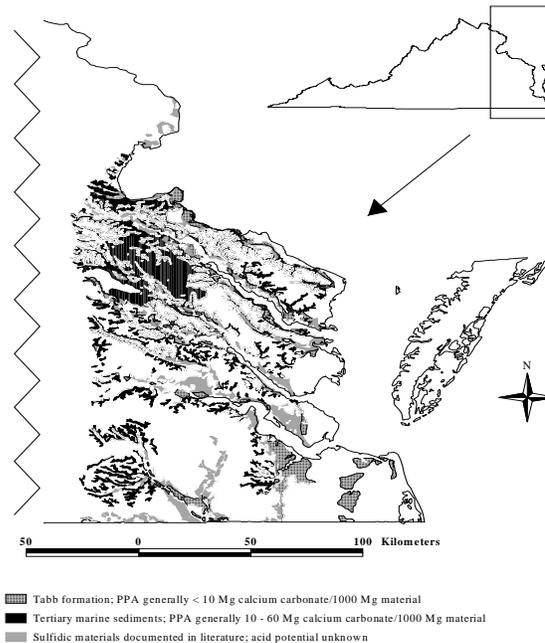
**Extent of acid-sulfate forming materials in Virginia Coastal Plain of Virginia that are within excavation depths (5 to 20 m). The darker shaded tertiary aged marine sediments are the most extensive and damaging.**

**However, a belt of Piedmont materials just to the west of Fredricksburg and Stafford is actually much more problematic!**

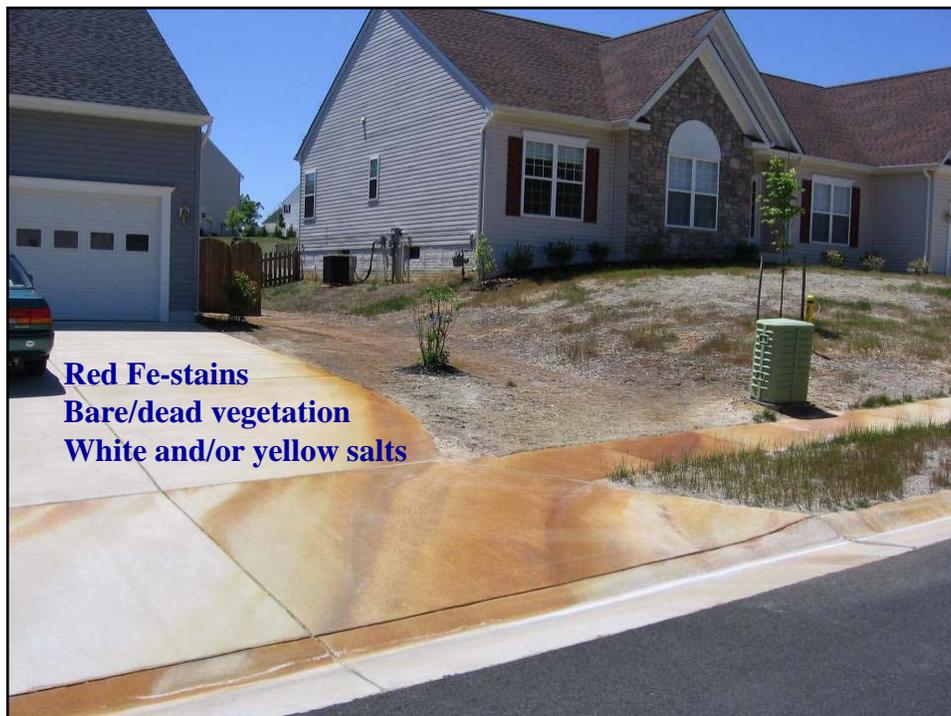
Overlying oxidized material is typically a light yellowish brown with pH ~ 3. The yellowish salt here is jarosite.

Underlying reduced material is typically drab blue or gray, with pH > 5.5. May be pH 7-8.

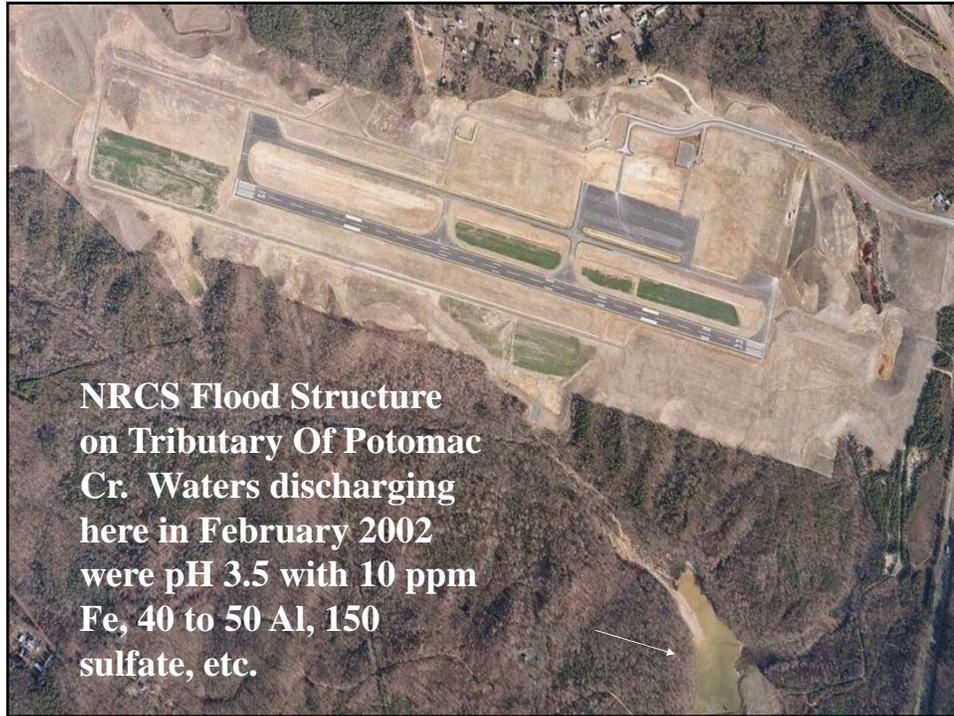
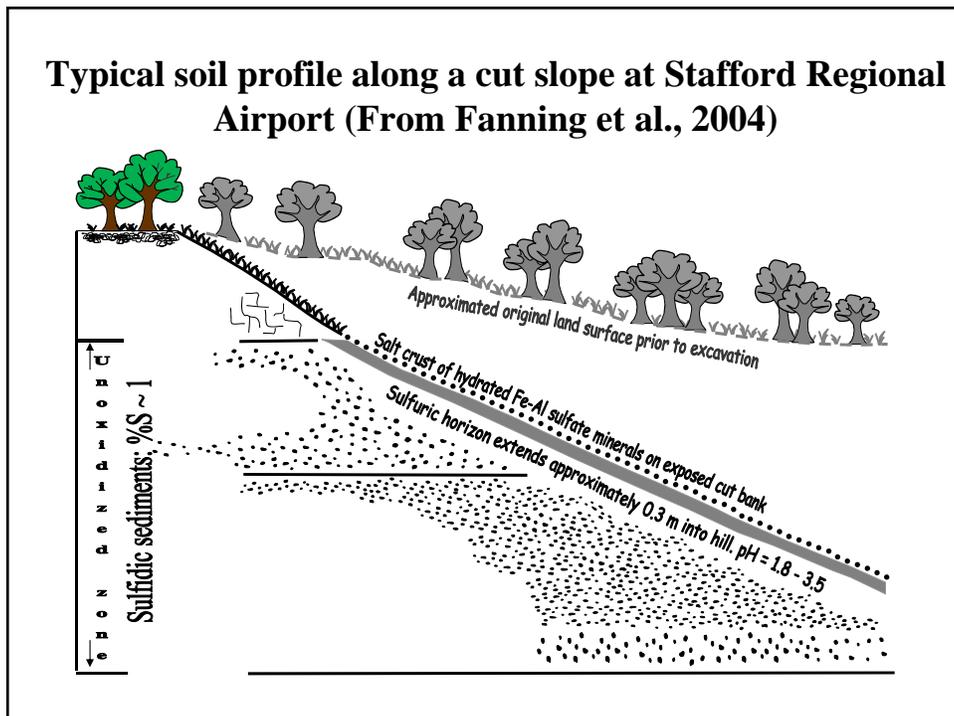
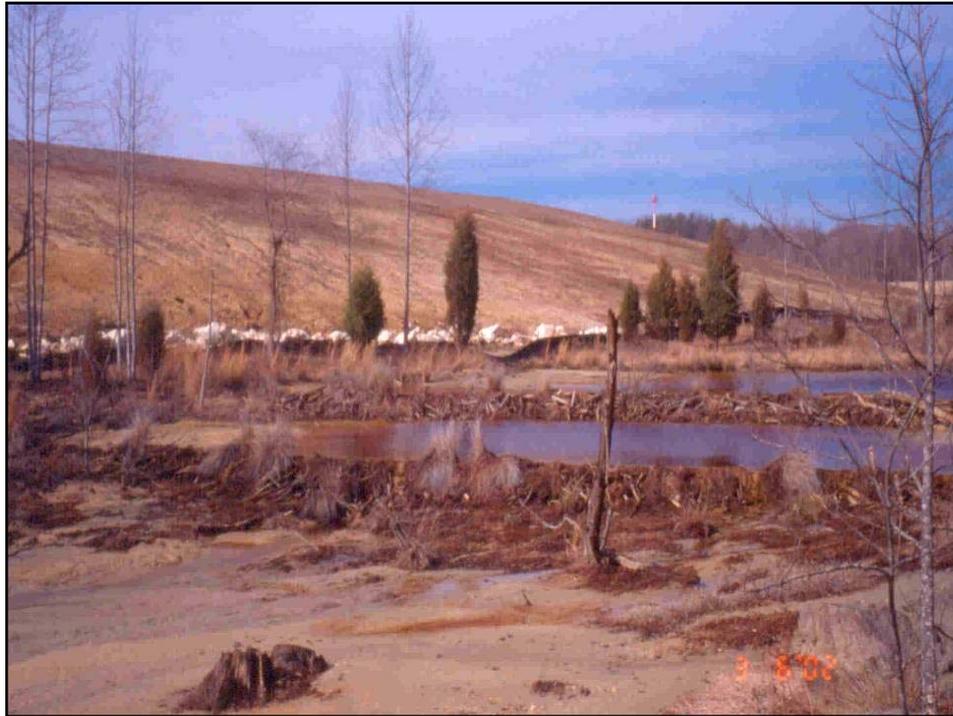
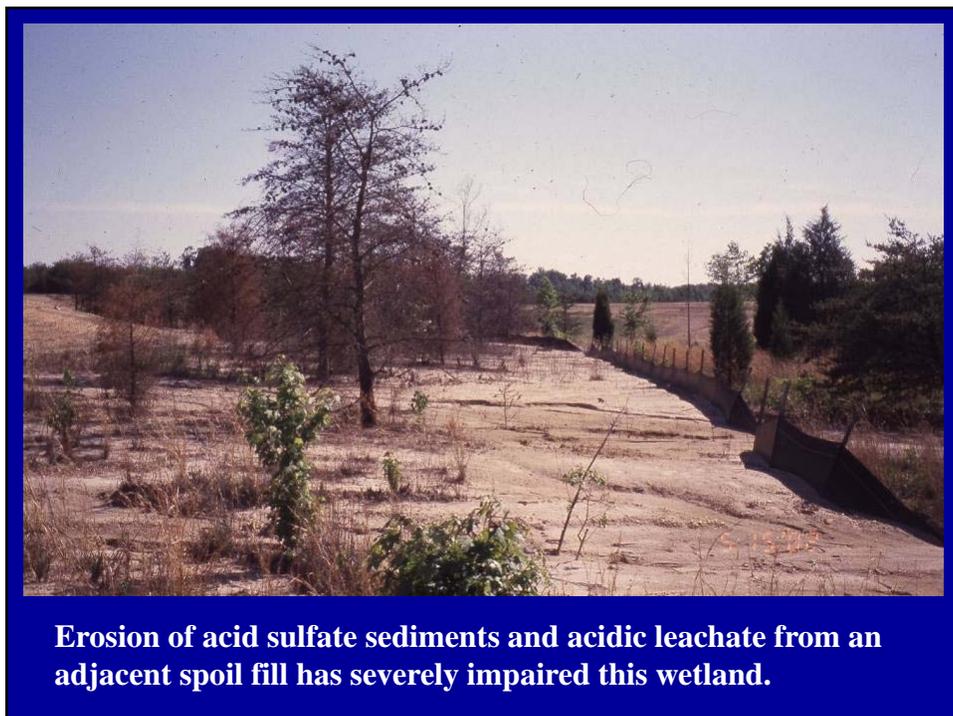
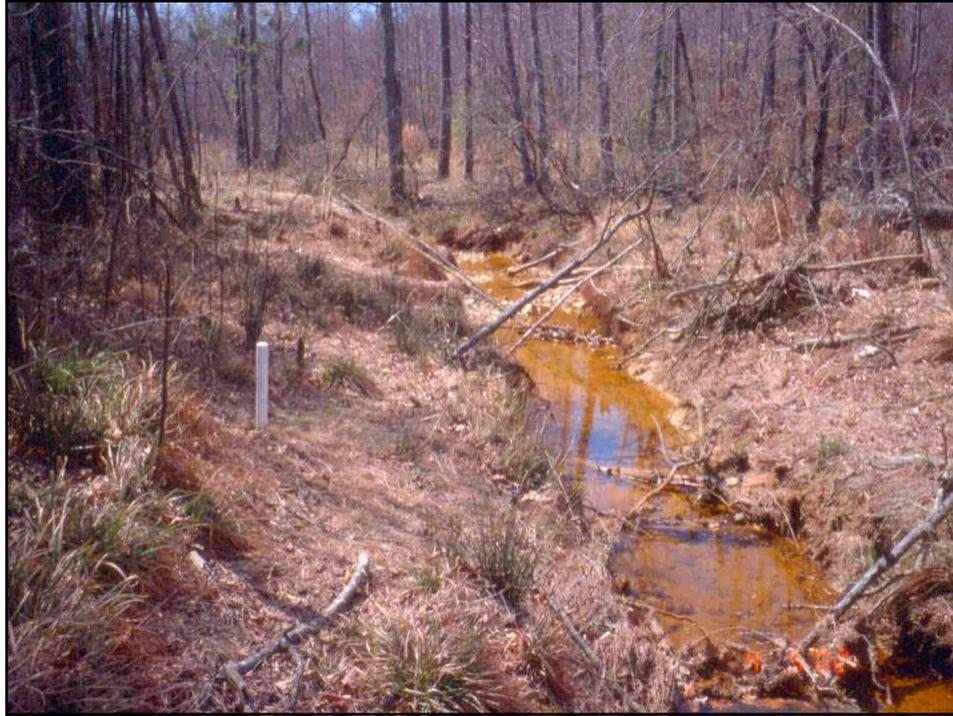
## The “wake up call”: Stafford Airport Project

- Approximately 400 acre cut-and-fill site was initiated in 1998 and supposedly completed in the fall of 2001.
- Site was inadvertently excavated through lower Tertiary sulfidic sediments which contain up to 2% pyritic-S.
- Average soil pH was less than 4.0; many areas were less than 3.0; some were 1.8!
- **Important:** We have no native vegetation adapted to the combination of  $\text{pH} < 3.8$  coupled with high salts!

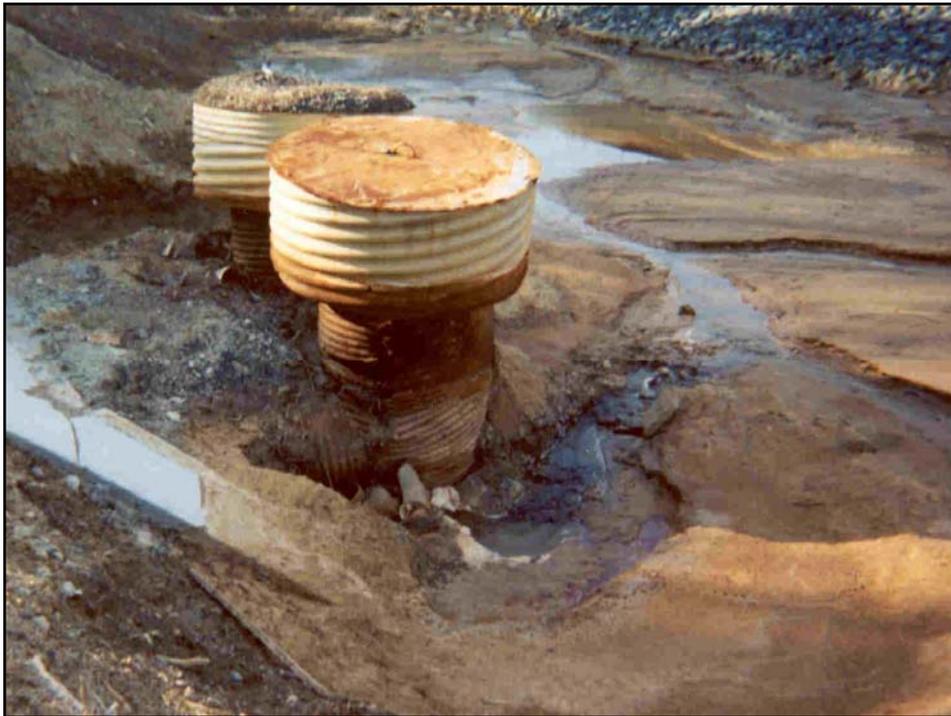
Inside the culvert at Clifton Forge.

## **Acid-S Attack on Metal**

**Direct dissolution of metals at  
low pH.**

**Salt induced corrosion.**

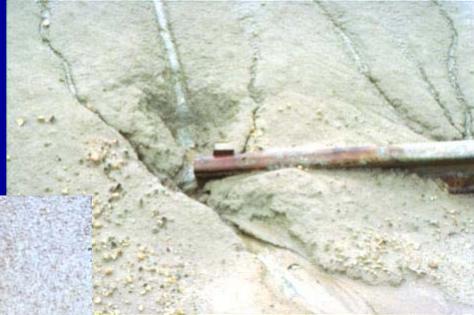
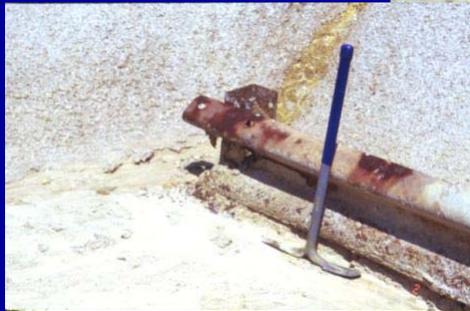
Within 5 years, erosion has removed over 30 cm of sediment...

...and the guardrail is severely corroded.

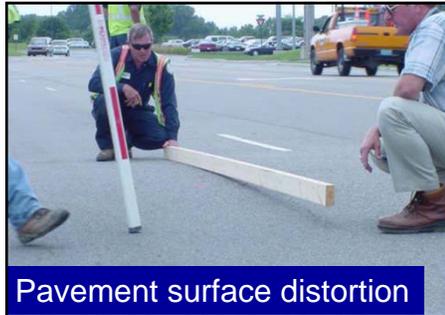
Pavement surface distortion

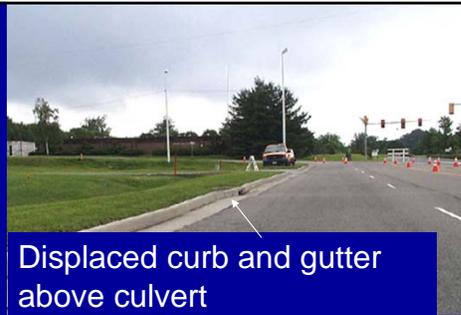
Displaced curb and gutter above culvert

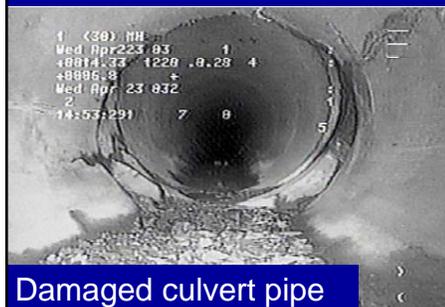
Damaged culvert pipe

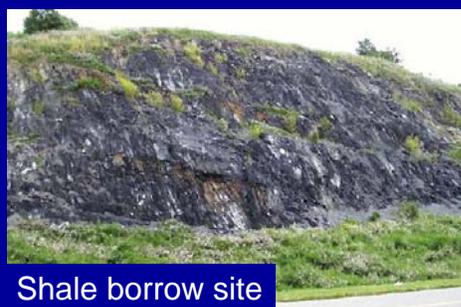
Shale borrow site

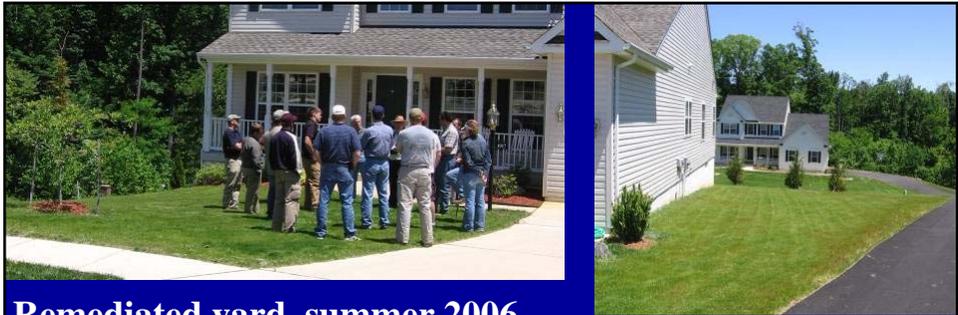
**Remediated yard, summer 2006**

**Neighbor's yard, Summer 2006**

- Recognize and avoid it first!
- Sample it and run appropriate lab analyses
- Add lime to offset potential acidity. May need lots of lime!
- Add organics like composted yardwaste or om biosolids
- Place it *quickly* below the permanent water table
- Keep groundwater out of it
- Apply protective coatings to concrete and metal
- More later on this!
