Effects of Acid-S Soils on Building Materials

Orndorff et al. (2001, 2002) studied effects of disturbance of sulfidic materials by VDOT.....

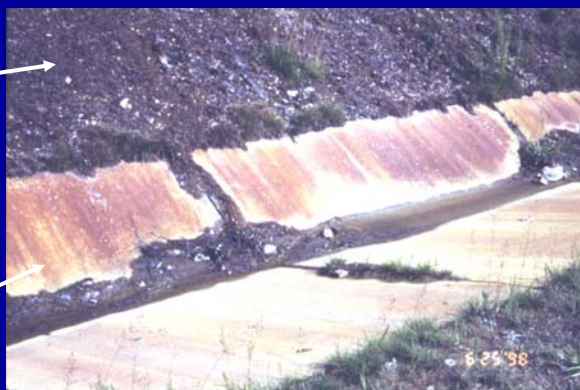
Poorly
established
vegetation

Iron
staining

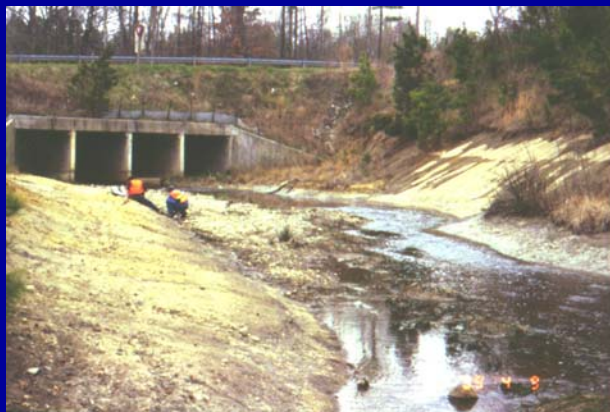
Chesterfield County: Proctor's Creek was redirected to this excavated channel during road construction.

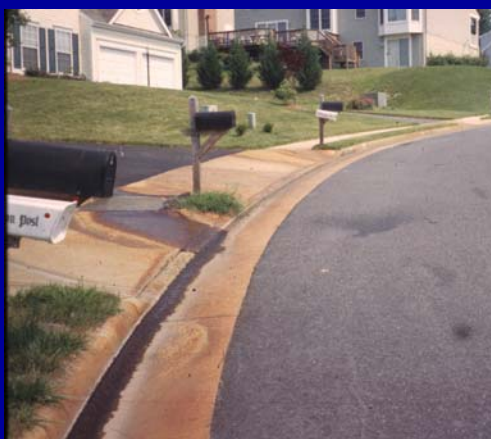
Iron-staining along curbs and sidewalks through the Hampton Oaks subdivision. Homeowners in this neighborhood apply the equivalent of 2 Mg agricultural lime per ha per month to maintain soil pH above 5.5.

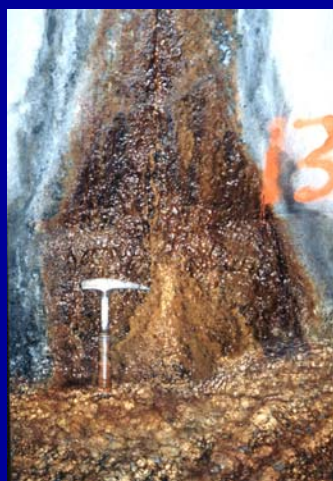
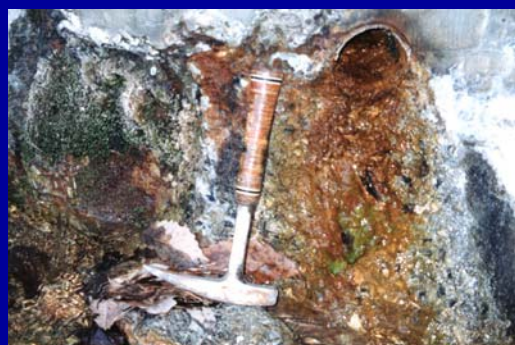
Inside the culvert at Clifton Forge.

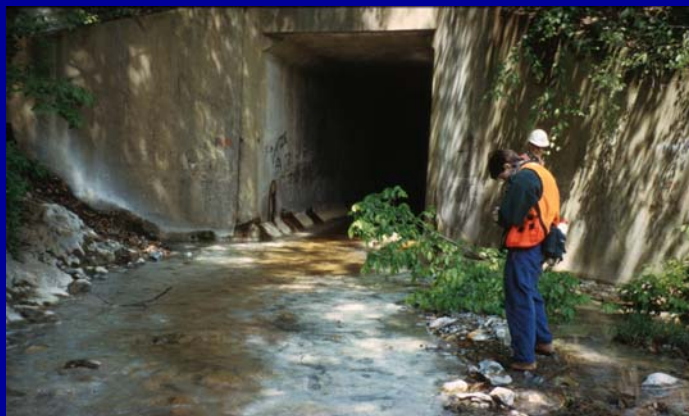
Culvert beneath I-64 in Clifton Forge

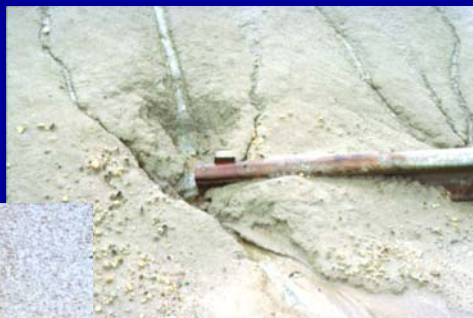
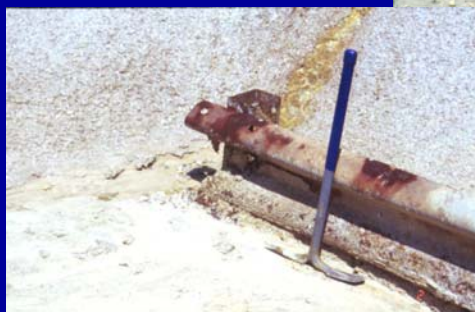
Within 5 years, erosion has removed over 30 cm of sediment...

...and the guardrail is severely corroded.

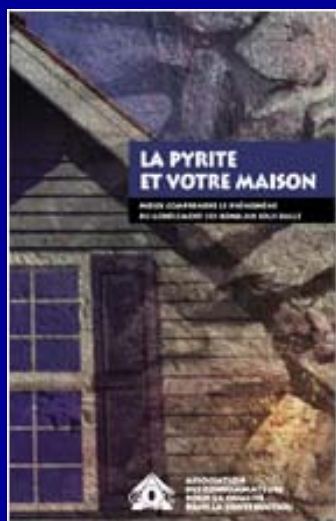
A Canadian consumers group (ACQC) publishes this pamphlet to promote public awareness of expansive pyritic shales. According to this group about 10,000 houses in eastern Canada are thought to be affected by pyrite oxidation.

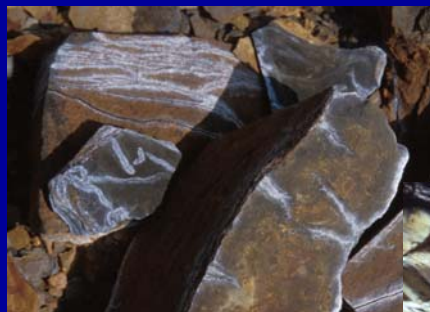
Sulfate salts precipitated in rock fractures.

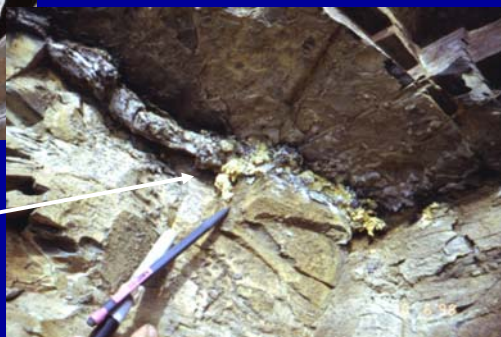
Copiapite (yellow) precipitated along the roadcut.
