During the 1980's the Virginia Department of Transportation (VDOT) started noticing problems.....

**In 1997 we began a four year study
with the following objectives:**

Compiling a state-wide sulfide hazard map for Virginia: materials and methods.

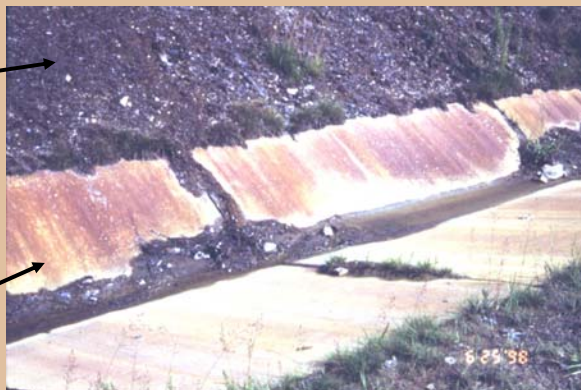
Stafford County, northern Virginia

Poorly
established
vegetation

Iron
staining

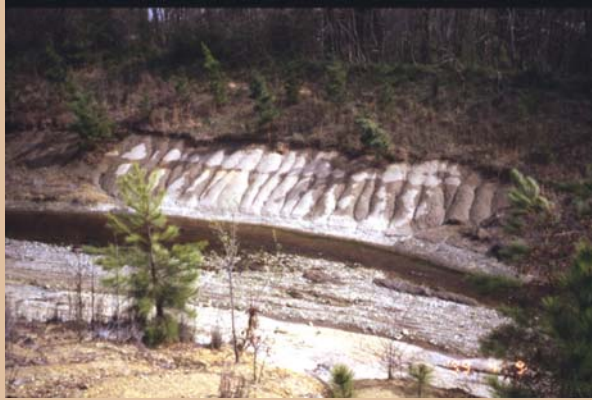
Chesterfield County, southeast Virginia.

**Vegetation
poorly
established
along channel
for diverted
creek.**

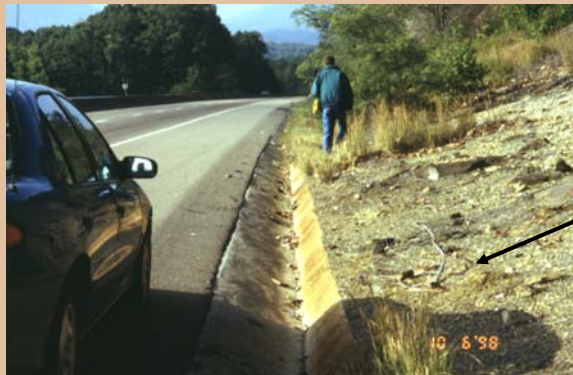
Wise County, southwest Virginia

**Iron
staining
and poorly
established
vegetation.**

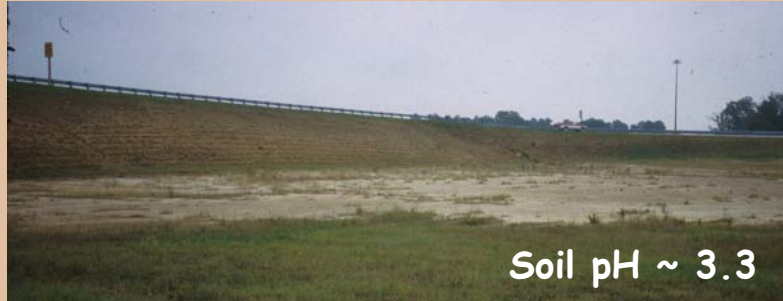
Roadcut along 64E in Suffolk.

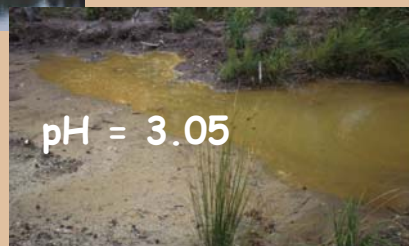
Runoff from stockpiled material at Hampton Roads Center. →

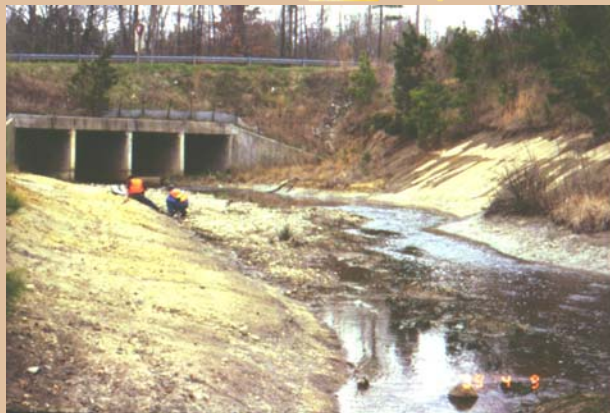
Chesterfield County: Proctor's Creek was redirected to this excavated channel during road construction.

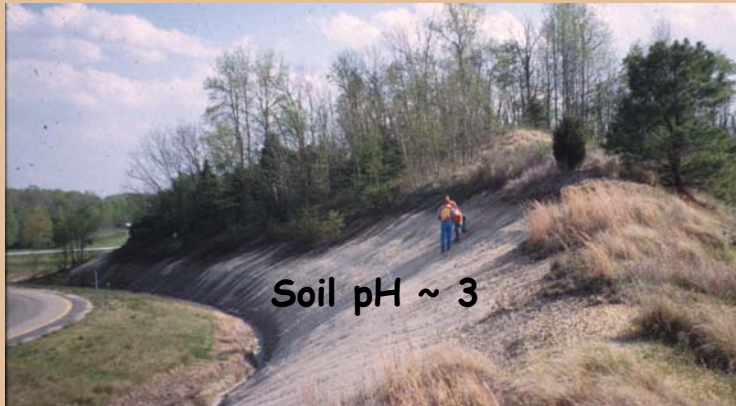
Interchange of I-295/Rt-360 in Mechanicsville.

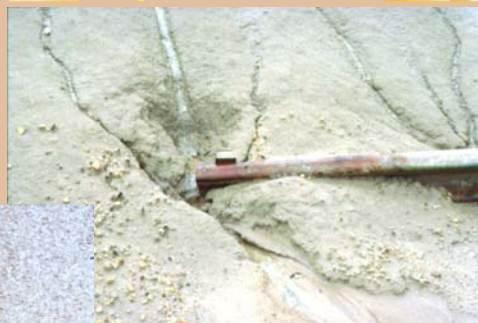
Within 5 years, erosion has removed over 30 cm of sediment...

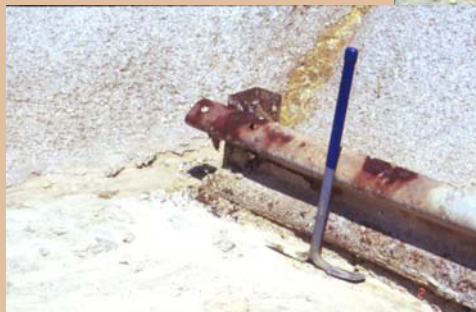
...and the guardrail is severely corroded.

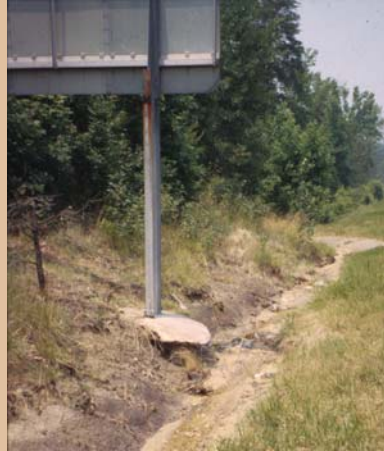
I-95 in Spotsylvania County. The stability of this sign is compromised by concrete degradation and erosion. Acid conditions (soil pH ~ 2.5) limit vegetation.

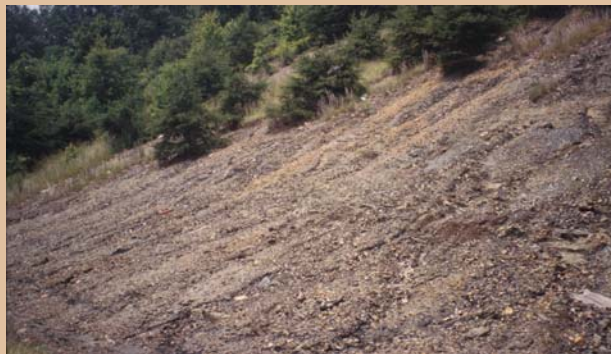
Roadcut along Mine Road in Stafford County.

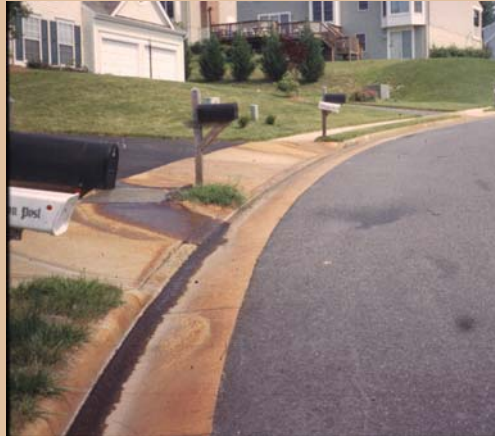
Iron-staining along curbs and sidewalks through the Hampton Oaks subdivision. Homeowners in this neighborhood apply the equivalent of 2 Mg agricultural lime per hectare per month to maintain soil pH above 5.5.

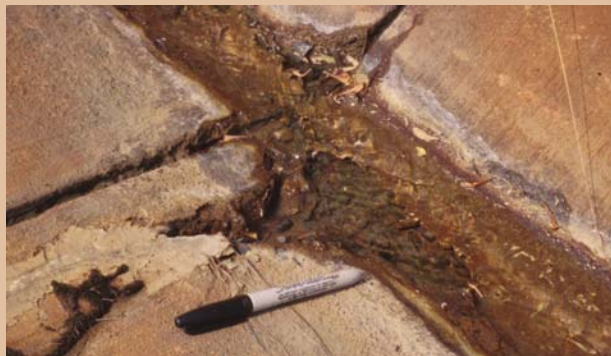
Concrete etching occurs when acid drainage "dissolves" out the cement, deteriorating the concrete.

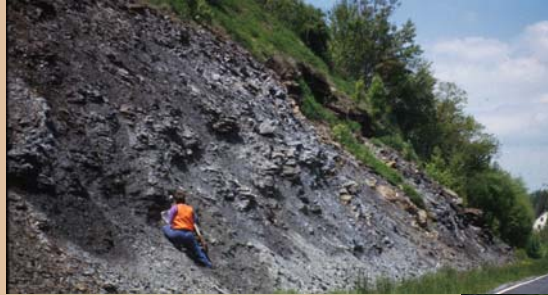
Rt-750, Floyd Co.

Drainage from this roadcut flows to the culvert on the right.

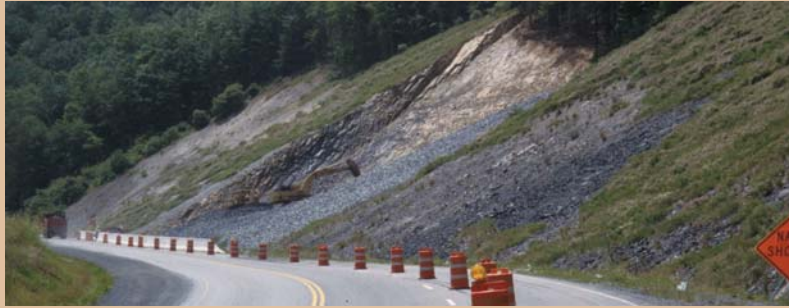
Exposure of the Millboro shale and Needmore Formation along Rt-250 in Highland County.

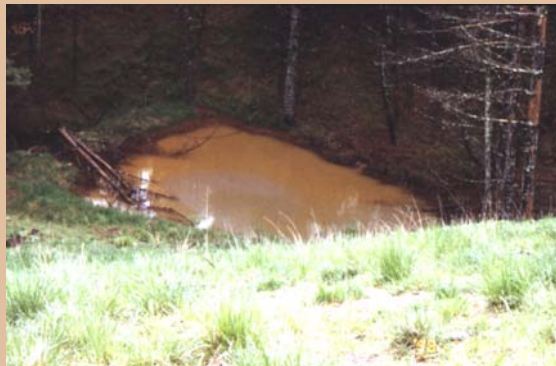
The Rt-250 roadcut drains to this sedimentation pond.

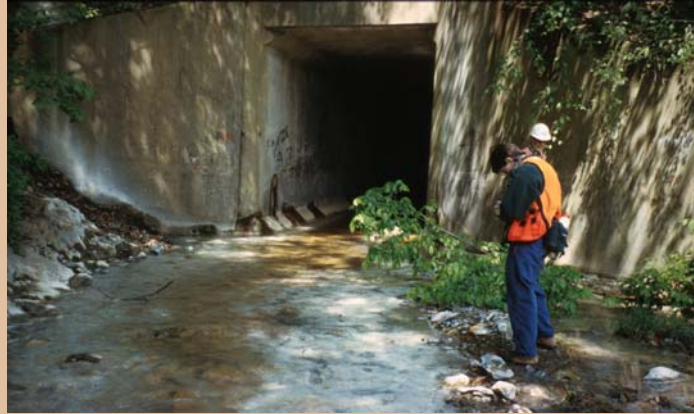
Culvert beneath I-64 in Clifton Forge

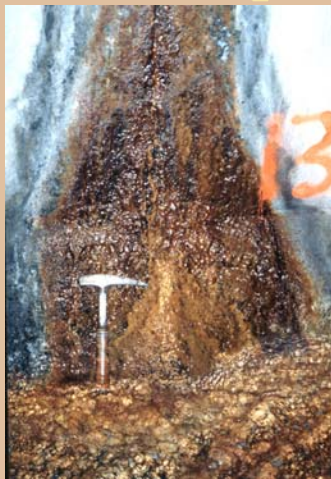
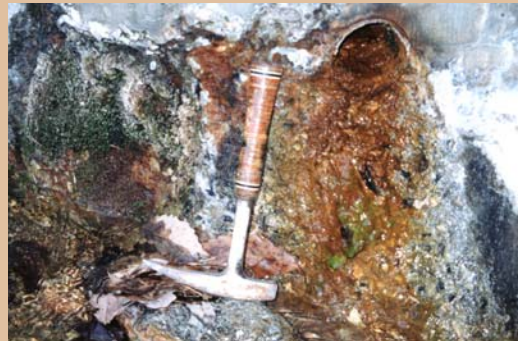
Inside the culvert at Clifton Forge.

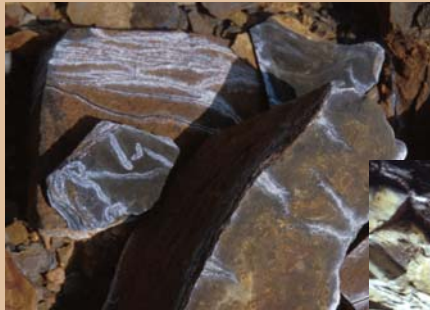
Sulfate salts precipitated in rock fractures.

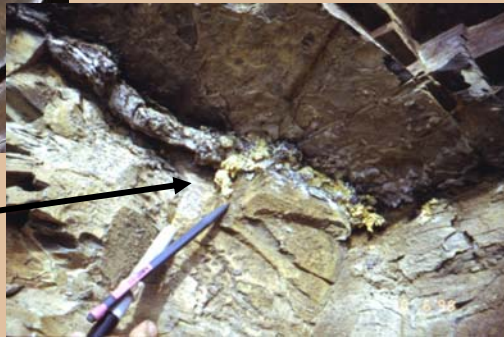
Copiapite precipitated along the roadcut.
