## **Major Impacts of Metal Mining, Smelting and Processing**

**Covered in Chaps. 28 (Gold mining), 32 (Metal mine tailings) and 33 (Smelter impacts) in your book.**

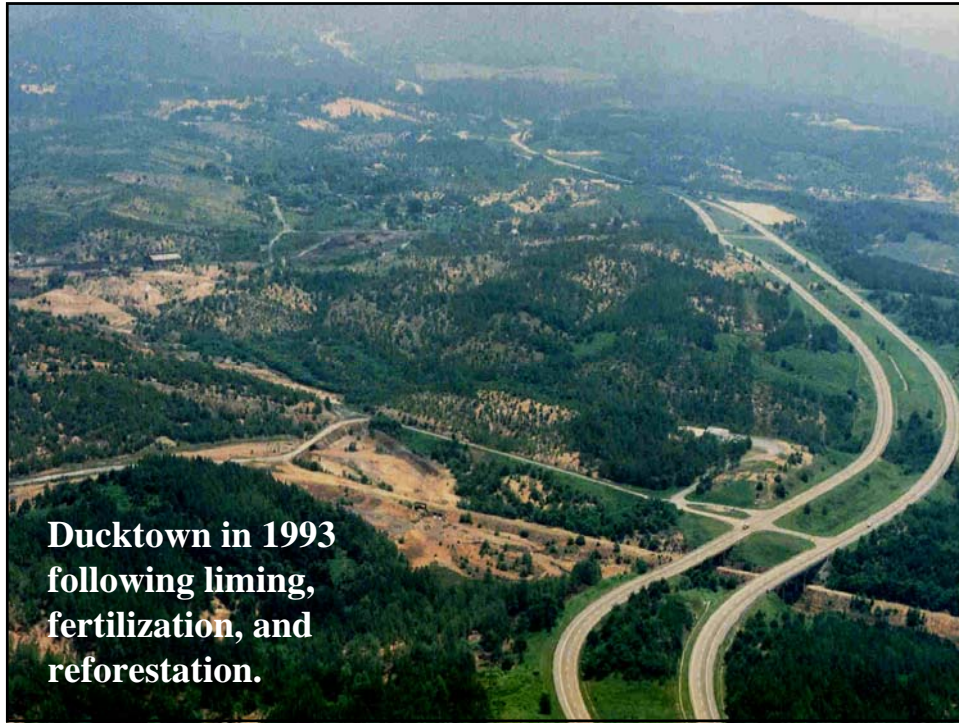
**Ducktown in 1993 following liming, fertilization, and reforestation.**

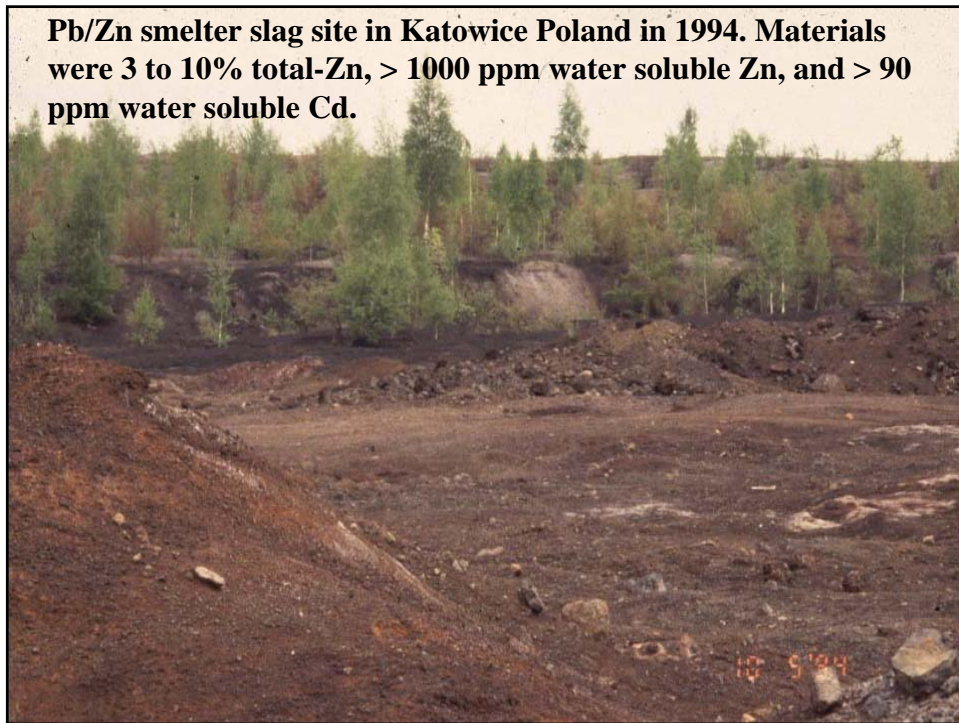
**Pb/Zn smelter slag site in Katowice Poland in 1994. Materials were 3 to 10% total-Zn, > 1000 ppm water soluble Zn, and > 90 ppm water soluble Cd.**
